## AVX-10K Application Initialization Issue

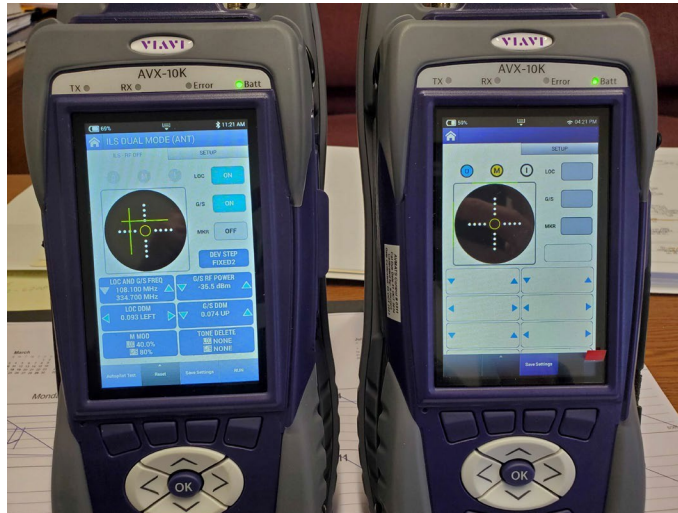
This Product Information Letter is to inform you of an issue with launching test applications on some units with serial numbers (S/N) 1000000758 and below (S/N located on the back of the unit). This symptom is a lengthy initialization time resulting in the application data fields not populating, as shown here:

*Figure 1: Data does not populate in the application data fields.*

Improvements have been made in software release 4.1.2 and above, but to fully correct this issue, a minor factory hardware modification is required. If your unit experiences this symptom, please contact customer care and request an [RMA](#) to receive this modification and a fresh calibration. If your unit is not experiencing this symptom, the modification will be performed on the next scheduled calibration. This issue does not affect performance. S/Ns 1000000758 and above have this modification implemented as of May 2024.
