Case Study

# High RTWP Problem Solved with InterferenceAdvisor

Two uplink (UL) bands were seriously affected by high received total wideband power (RTWP).

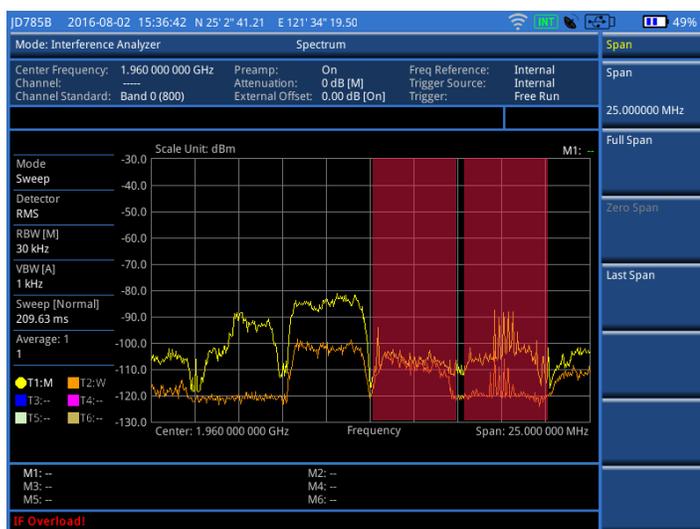
- Problem site with very high RTWP
- Issue was difficult to troubleshoot as it was intermittent
- Intermittent interference level was as high as -88 dBm to -78 dBm

Two UL Channels reported High RTWP

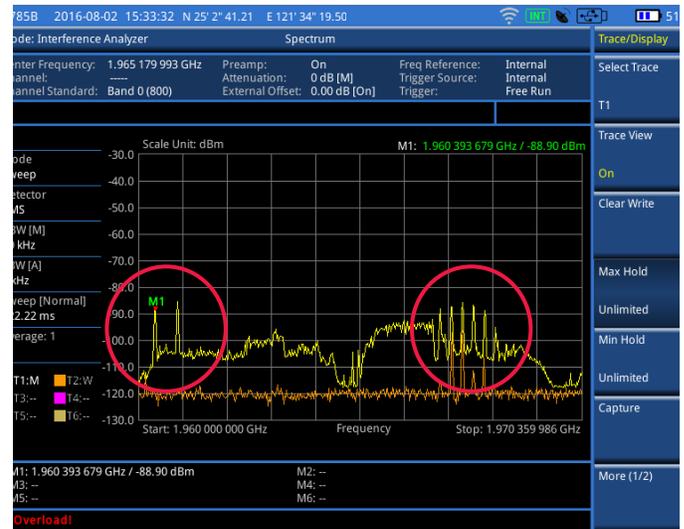
Multiple-peak interference observed in two UL Channels

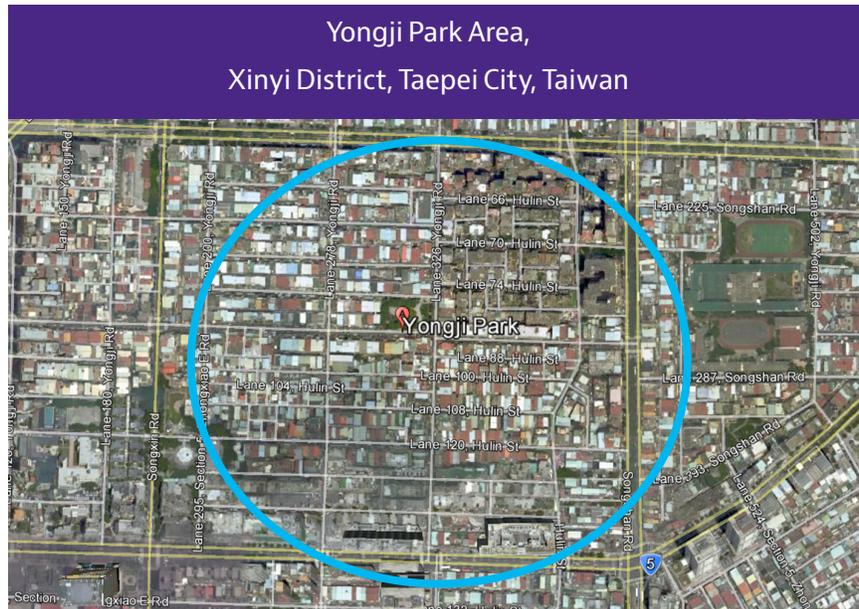
The following map illustrates the problem area the Taiwan operator was experiencing. After driving the large area, including the site where the problem was initially reported, the team could observe multiple peaks of interference signals affecting 2 UL in-service channels. This was the interferer they needed to shut down.

Problem area with high RTWP problem (Yongji Park Area)

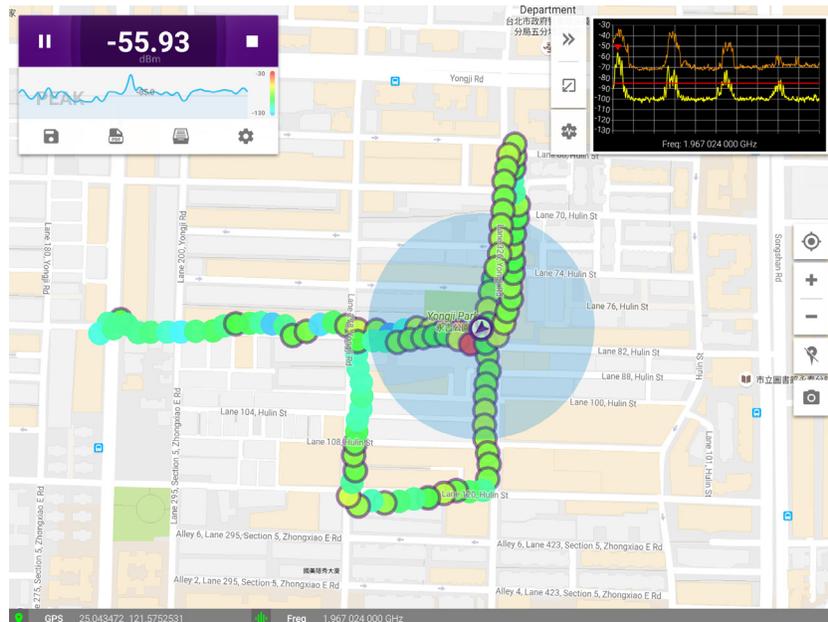
After 30 minutes of drive testing around the strongest signal area, the EagleEye™ software indicated the most probable source area.

Most probable area found by EagleEye software (large blue circle)

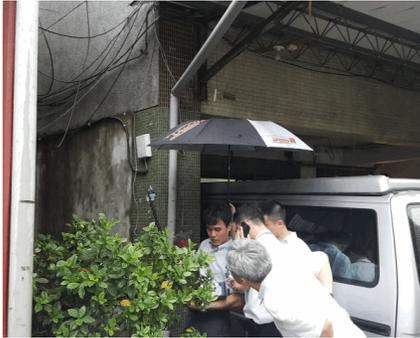
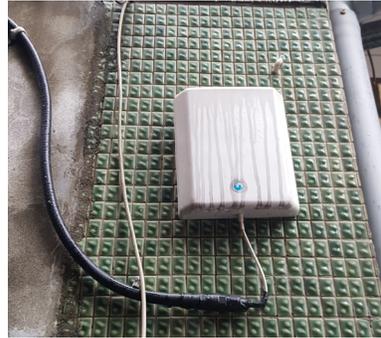
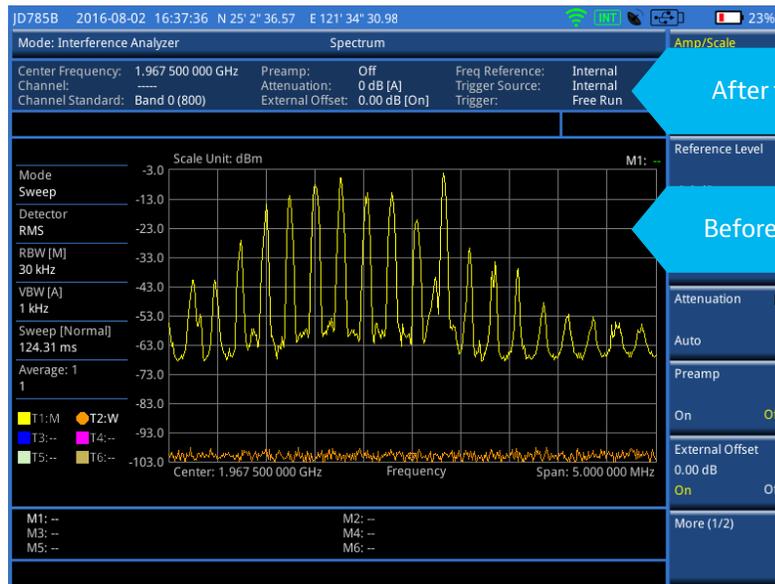
They successfully located the source of interference: an RF repeater hanging on a wall.

After turning off the repeater

Before turning off the repeater

The team contacted the owner of the repeater, and as soon as it was turned off, the interference signature was gone. Problem solved.
