Case Study

Distortion in UL Service Bands Repeater Saturation Resolved with InterferenceAdvisor

RF repeater saturation caused wide band noise, affecting all WCDMA service bands.

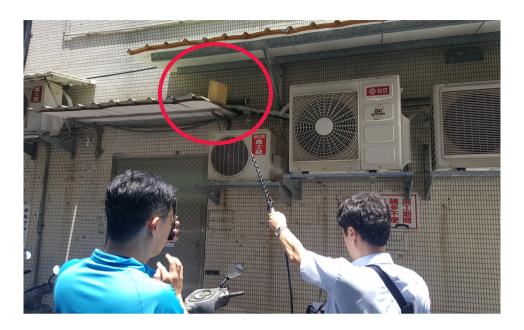
An RF engineer conducted a local interference hunt with VIAVI CellAdvisor TM and AntennaAdvisor to locate the interference source on foot.

Manually locating the source in the suspected area

The source of the interference was quickly identified as a repeater installed on the first floor of one of the residences. Due to its saturation, the adjacent cell site received an unusually high signal, raising the noise floor across all service bands. Proper gain control of the repeater resolved the problem.
